**Flood Control Project Maintenance  
Levee Inspections**  
**LMA District Cover Sheet**  
**Spring 2019 Levee Inspection Results**

**Reclamation District No. 0003 Grand Island**

**Spring 2019 Levee Inspection Results**

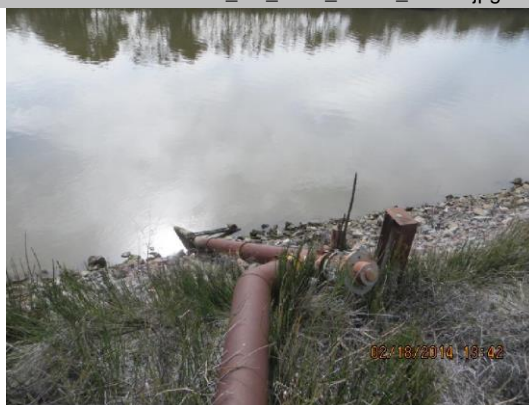
Photo 2 of 2 : UCIP\_SP\_2019\_30404\_55923.jpg

Pipe and slant pump visible on WS slope.

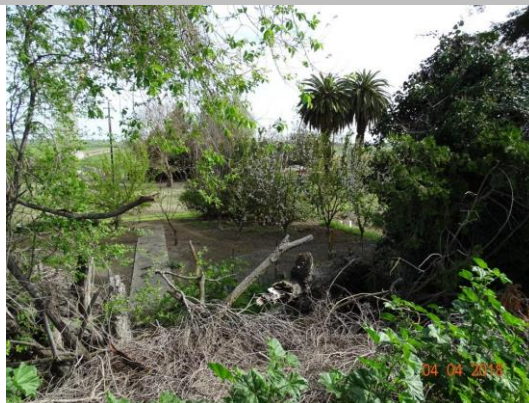
Photo 1 of 1 : SP\_2019\_RD0003\_25\_170\_20190311\_00146.jpg

LM Start	10.15	Rating **	U	Issue No.	170
LM End	10.15	Issue Type +	En	Location *	LS
Category	Earthen Levee			GPS Latitude/Longitude	
				Start	End
Item	Encroachments			38.241125 °	38.241125 °
				-121.542075 °	-121.542075 °
DWR ID	DWR_RD0003_02_s_2018_170				
Comment Code					
TR : Tree or limb					
Inspector Comment					
There is a fallen tree on the landside slope.

Fallen tree on landside slope.

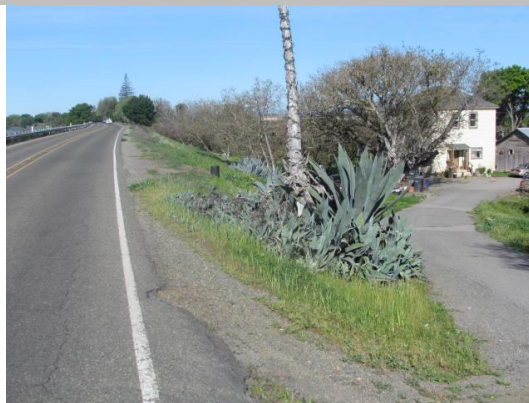
Photo 1 of 2 : SP\_2019\_RD0003\_25\_81\_20190311\_00059.jpg

LM Start	10.43	Rating **	M	Issue No.	81
LM End	10.43	Issue Type +	En	Location *	LS
Category	Earthen Levee			GPS Latitude/Longitude	
				Start	End
Item	Vegetation			38.239850 °	38.239850 °
				-121.537237 °	-121.537237 °
DWR ID	DWR_RD0003_02_s_2013_81				
Comment Code					
V6 : Landscaping					
Inspector Comment					
There is a century plant on the landside shoulder.

Looking west at century plant on landward slope. (Spring 2015)

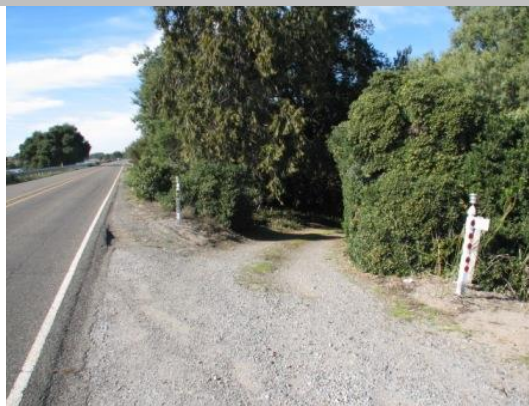
Photo 1 of 1 : SP\_2019\_RD0003\_25\_66\_20190311\_00043.jpg

LM Start	10.53	Rating **	U	Issue No.	66
LM End	10.53	Issue Type +	En	Location *	LS
Category	Earthen Levee			GPS Latitude/Longitude	
				Start	End
Item	Vegetation			38.239462 °	38.239462 °
				-121.535462 °	-121.535462 °
DWR ID	DWR_RD0003_02_s_2012_66				
Comment Code					
V6 : Landscaping					
Inspector Comment

Landscaping on levee slope and toe obstructs access and visibility.

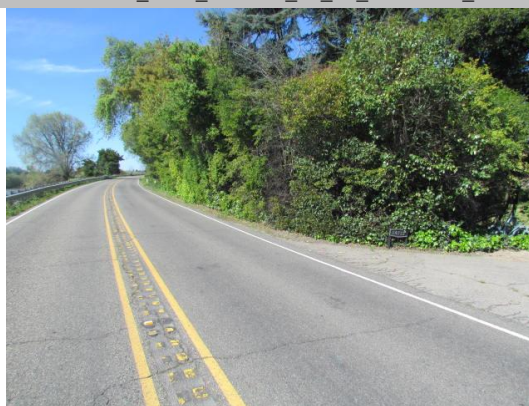
Photo 1 of 1 : SP\_2019\_RD0003\_25\_68\_20190311\_00044.jpg

LM Start	10.74	Rating **	U	Issue No.	68
LM End	10.90	Issue Type +	En	Location *	LS
Category	Earthen Levee			GPS Latitude/Longitude	
				Start	End
Item	Vegetation			38.238788 °	38.238959 °
				-121.531698 °	-121.528758 °
DWR ID	DWR_RD0003_02_s_2012_68				
Comment Code					
V6 : Landscaping					
Inspector Comment

Looking west at dense landscaping on landward shoulder and slope.

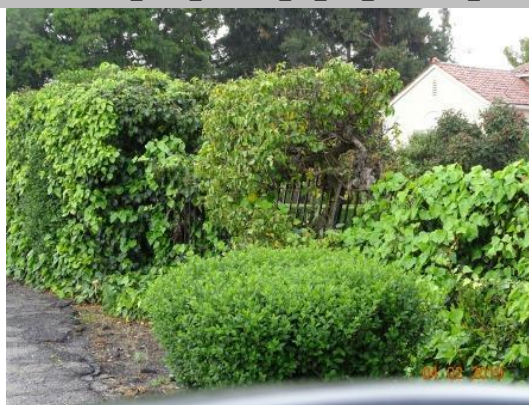
Photo 1 of 1 : SP\_2019\_RD0003\_25\_183\_20190404\_00333.jpg

LM Start	10.75	Rating **	U	Issue No.	183
LM End	10.79	Issue Type +	En	Location *	LS
Category	Earthen Levee			GPS Latitude/Longitude	
				Start	End
Item	Encroachments			38.238772 °	38.238753 °
				-121.531523 °	-121.530789 °
DWR ID	DWR_RD0003_02_s_2019_183				
Comment Code					
FE : Fence					
Inspector Comment					
There is a wrought iron fence on the landside.

View of wrought iron fence on the landside shoulder (Spring 2019).

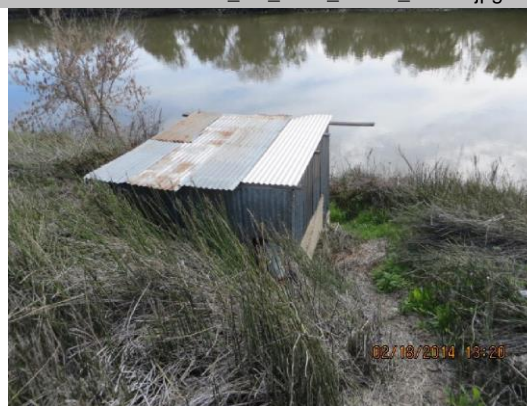
Photo 1 of 3 : UCIP\_SP\_2019\_30391\_55899.jpg

Comment Code						
Inspector Comment						
FS_ID:30391 DS_ID:22284 EP_NO: 9442 Repair Type: Non-Urgent Crossing Status: Found UCIP Comments: Good candidate for video inspection. FIELD_STRUCT_DESC: 8-inch steel irrigation discharge pipe through the levee, invert elevation 7.5 feet below the crown. Pump and gate valve on the waterside (WS) slope. 4-foot by 4-foot concrete distribution box at the landside (LS) toe, next to a power pole and meter. 1.5-inch electrical conduit through the levee at the same location. (Retention of an irrigation pumping plant, centrifugal pump, and accessories in a corrugated metal shed on the WS levee slope and an 8-inch pipe through the levee above the floodplain authorized under Automatic Board Order (ABO) issued as Permit No. 9442, 1974 - Frank Gwerder). [Additional Reference(s): DWR Levee Log, 1993. USACE Sacramento O&M Manual 104, February 1960, (RM 25.74), 6-inch pipe referenced]. FS Date: 2/18/2014

Pump and gate valve in pumphouse on WS slope.

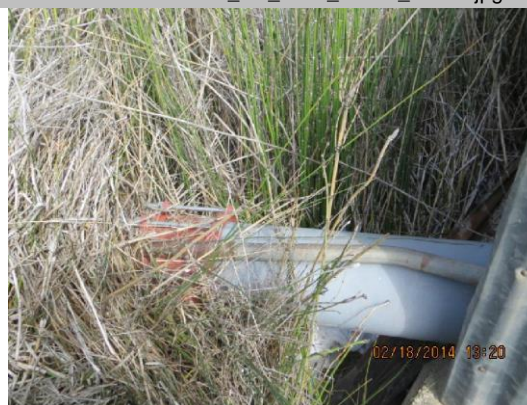
Photo 2 of 3 : UCIP\_SP\_2019\_30391\_55898.jpg

Pipe and conduit visible on WS slope.

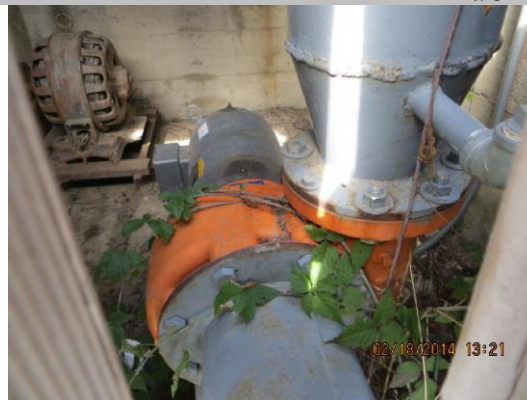
Photo 3 of 3 : UCIP\_SP\_2019\_30391\_55897.jpg

Item	DWR UCIP Field Study			38.238768 °	38.238768 °	
				-121.531512 °	-121.531512 °	
DWR ID	22284					
Comment Code						
Inspector Comment						
FS_ID:30391 DS_ID:22284 EP_NO: 9442 Repair Type: Non-Urgent Crossing Status: Found UCIP Comments: Good candidate for video inspection. FIELD_STRUCT_DESC: 8-inch steel irrigation discharge pipe through the levee, invert elevation 7.5 feet below the crown. Pump and gate valve on the waterside (WS) slope. 4-foot by 4-foot concrete distribution box at the landside (LS) toe, next to a power pole and meter. 1.5-inch electrical conduit through the levee at the same location. (Retention of an irrigation pumping plant, centrifugal pump, and accessories in a corrugated metal shed on the WS levee slope and an 8-inch pipe through the levee above the floodplain authorized under Automatic Board Order (ABO) issued as Permit No. 9442, 1974 - Frank Gwerder). [Additional Reference(s): DWR Levee Log, 1993. USACE Sacramento O&M Manual 104, February 1960, (RM 25.74), 6-inch pipe referenced]. FS Date: 2/18/2014

Pump in pumphouse on WS slope.

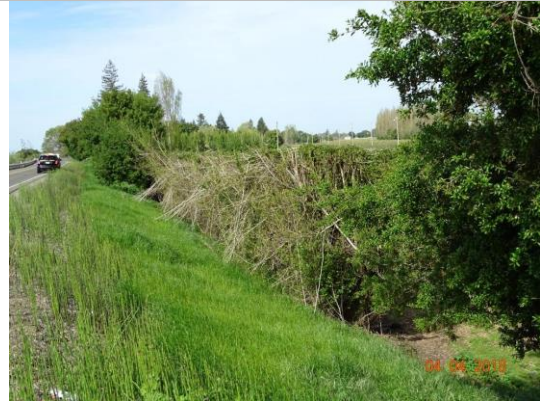
Photo 1 of 1 : SP\_2019\_RD0003\_25\_160\_20190311\_00138.jpg

LM Start	10.90	Rating **	U	Issue No.	160
LM End	11.08	Issue Type +	En	Location *	LS
Category	Earthen Levee			GPS Latitude/Longitude	
				Start	End
Item	Vegetation			38.238962 °	38.239706 °
				-121.528842 °	-121.525707 °
DWR ID	DWR_RD0003_02_s_2018_160				
Comment Code					
V6 : Landscaping					
Inspector Comment					
Row of closely-spaced trees at landside toe inhibits inspection and prevents access.

Trees at landside toe.

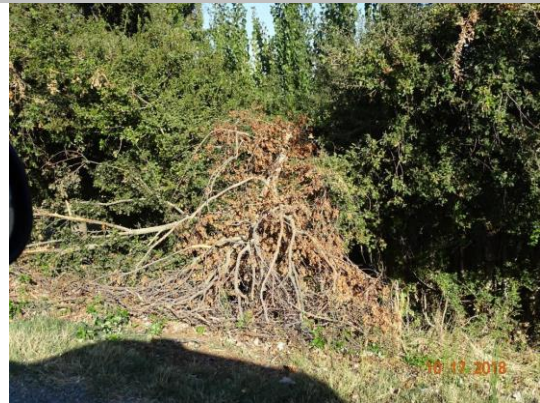
Photo 1 of 1 : SP\_2019\_RD0003\_25\_163\_20190311\_00139.jpg

LM Start	10.99	Rating **	M	Issue No.	163
LM End	10.99	Issue Type +	Ma	Location *	LS
Category	Earthen Levee			GPS Latitude/Longitude	
				Start	End
Item	Encroachments			38.239377 °	38.239377 °
				-121.527177 °	-121.527177 °
DWR ID	DWR_RD0003_02_f_2018_163				
Comment Code					
TR : Tree or limb					
Inspector Comment					
Remove dead branch from the landside slope.

View of dead branch on landside slope (October 2018).

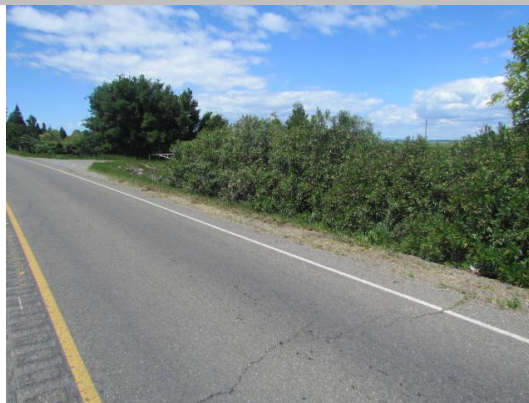
Photo 2 of 2 : SP\_2019\_RD0003\_25\_84\_20190311\_00065.jpg

LM Start	11.10	Rating **	U	Issue No.	84 (cont)	
LM End	11.10	Issue Type +	En	Location *	LS	
Category	Earthen Levee			GPS Latitude/Longitude		
				Start		End
Item	Vegetation			38.239730 °		38.239730 °
				-121.525190 °		-121.525190 °
DWR ID	DWR_RD0003_02_s_2013_84					
Comment Code						
V6 : Landscaping						
Inspector Comment						
Oleander and cactus are on the landside shoulder.

Looking northwest at dense landscaping on landward shoulder and slope.

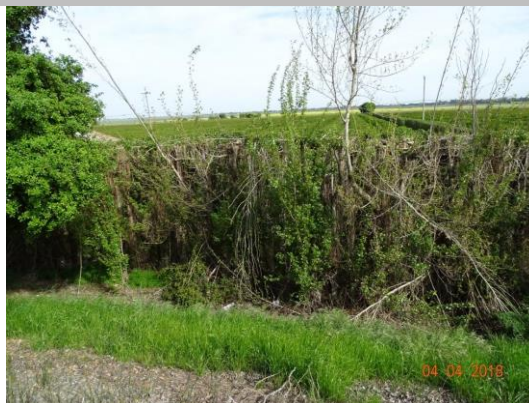
Photo 1 of 1 : SP\_2019\_RD0003\_25\_153\_20190311\_00133.jpg

LM Start	11.13	Rating **	U	Issue No.	153
LM End	11.13	Issue Type +	En	Location *	LS
Category	Earthen Levee			GPS Latitude/Longitude	
				Start	End
Item	Vegetation			38.239858 °	38.239858 °
				-121.524747 °	-121.524747 °
DWR ID	DWR_RD0003_02_s_2018_153				
Comment Code					
V6 : Landscaping					
Inspector Comment					
Row of closely-spaced trees at landside toe inhibits inspection and prevents access.

Row of trees at landside toe.

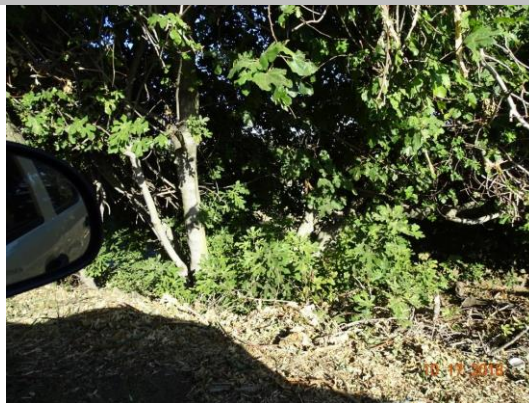
Photo 1 of 1 : SP\_2019\_RD0003\_25\_148\_20190311\_00122.jpg

LM Start	11.21	Rating **	U	Issue No.	148
LM End	11.21	Issue Type +	Ma	Location *	LS
Category	Earthen Levee			GPS Latitude/Longitude	
				Start	End
Item	Trim / Thin Trees			38.239968 °	38.239968 °
				-121.523293 °	-121.523293 °
DWR ID	DWR_RD0003_02_f_2018_148				
Comment Code					
T1 : Trim trees to at least five feet above ground level.					
Inspector Comment					
Trim fig trees that are sprouting.

View of newly sprouting fig trees on the landside slope (October 2018).

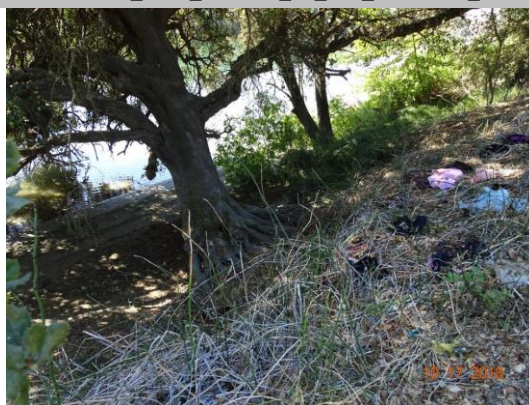
Photo 1 of 3 : SP\_2019\_RD0003\_25\_118\_20190311\_00080.jpg

LM Start	11.33	Rating **	M	Issue No.	118
LM End	11.41	Issue Type +	Ma	Location *	WS
Category	Supplemental			GPS Latitude/Longitude	
				Start	End
Item	2017 USACE Erosion Survey, DRAFT			38.239870 °	38.239992 °
				-121.520989 °	-121.519542 °
DWR ID	DWR_RD0003_02_f_2018_118				
Comment Code					
Inspector Comment					
2017 Site ID: SAC 26.3 R					
Status: Repaired					
2018: Still pocket of erosion into waterside toe.					
2017 Field Notes: Repaired by locals.					
Site History: 2009 - Hole left in levee toe from a fallen tree. Could be repaired under maintenance. 2010 - Minor new erosion. 2015 - Minor new erosion at toe.

View of erosion at the waterside toe (October 2018).

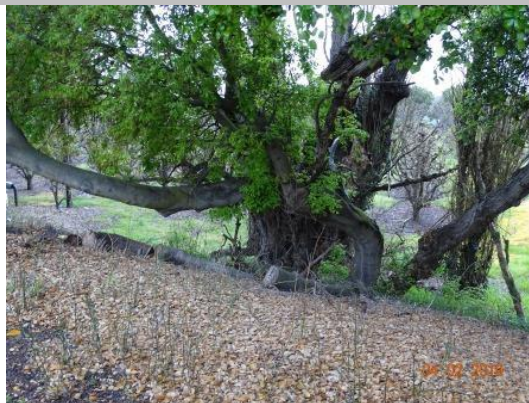
Photo 1 of 1 : SP\_2019\_RD0003\_25\_162\_20190404\_00332.jpg

LM Start	11.43	Rating **	M	Issue No.	162
LM End	11.43	Issue Type +	En	Location *	LS
Category	Earthen Levee			GPS Latitude/Longitude	
				Start	End
Item	Encroachments			38.240198 °	38.240198 °
				-121.519290 °	-121.519290 °
DWR ID	DWR_RD0003_02_s_2019_162				
Comment Code					
TR : Tree or limb					
Inspector Comment					
Remove tree limbs from the landside slope.

View looking downslope at fallen tree limbs on the landside slope (Spring 2019).

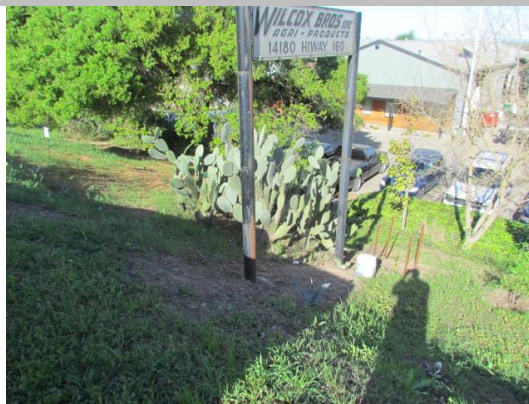
Photo 1 of 1 : SP\_2019\_RD0003\_25\_155\_20190311\_00135.jpg

LM Start	11.58	Rating **	M	Issue No.	155
LM End	11.58	Issue Type +	En	Location *	LS
Category	Earthen Levee			GPS Latitude/Longitude	
				Start	End
Item	Vegetation			38.241412 °	38.241412 °
				-121.517027 °	-121.517027 °
DWR ID	DWR_RD0003_02_s_2015_155				
Comment Code					
V6 : Landscaping					
Inspector Comment					
Remove cactus from the landside slope.

Looking southwest at cactus on landward slope and toe.

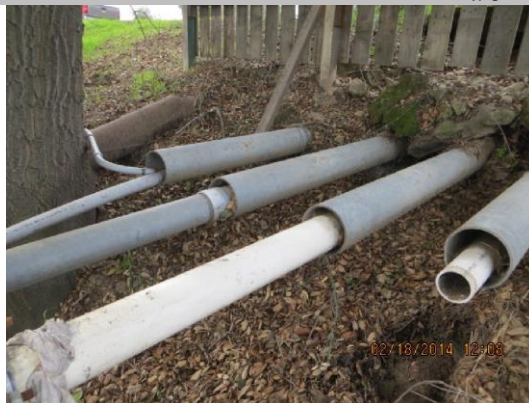
Photo 2 of 2 : UCIP\_SP\_2019\_30352\_55823.jpg

LM Start	11.62	Rating **	M	Issue No.	985 (cont)	
LM End	11.62	Issue Type +	En	Location *		
Category	Supplemental			GPS Latitude/Longitude		
				Start		End
Item	DWR UCIP Field Study			38.241869 °		38.241869 °
				-121.516436 °		-121.516436 °
DWR ID	22320					
Comment Code						
Inspector Comment						
FS_ID:30352 DS_ID:22320 EP_NO: 16053 Repair Type: Non-Urgent Crossing Status: Found UCIP Comments: Annular space not grouted. FIELD_STRUCT_DESC: 1 of 4: 6-inch galvanized iron electrical conduit through the levee, 3 feet below the crown. 2-inch polyvinyl chloride (PVC) and 1-inch PVC electrical conduits sleeved through the 6-inch conduit. (Plans to install four 6-inch pipe casings through the levee authorized under Permit No. 16053, 1993 - Vollman-Clark Ranch, DCC Engineering Company, Inc). FS Date: 2/18/2014

Both electrical conduits and 6-inch galvanized iron conduit visible at left in photo.

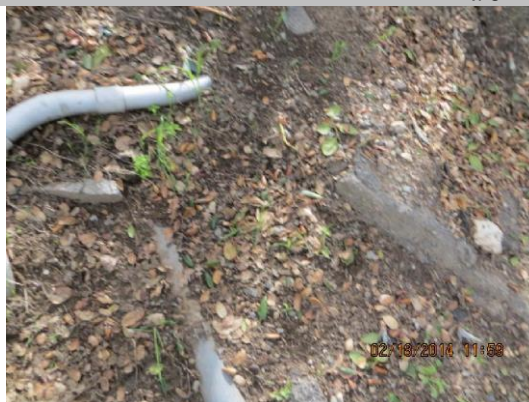
Photo 1 of 3 : UCIP\_SP\_2019\_30353\_55827.jpg

LM Start	11.63	Rating **	M	Issue No.	986
LM End	11.63	Issue Type +	En	Location *	
Category	Supplemental			GPS Latitude/Longitude	
				Start	End
Item	DWR UCIP Field Study			38.241872 °	38.241872 °
				-121.516433 °	-121.516433 °
DWR ID	22356				
Comment Code					
Inspector Comment					
FS_ID:30353 DS_ID:22356 EP_NO: 16053 Repair Type: Non-Urgent Crossing Status: Found UCIP Comments: Annular space not grouted. FIELD_STRUCT_DESC: 2 of 4: 6-inch galvanized iron electrical conduit through the levee, 3 feet below the crown. 4-inch steel electrical conduit sleeved through the 6-inch conduit. Electrical panel visible on the landside (LS) toe. (Plans to install four 6-inch pipe casings through the levee authorized under Permit No. 16053, 1993 - Vollman-Clark Ranch, DCC Engineering Company, Inc). FS Date: 2/18/2014

Electrical conduit visible on LS slope.

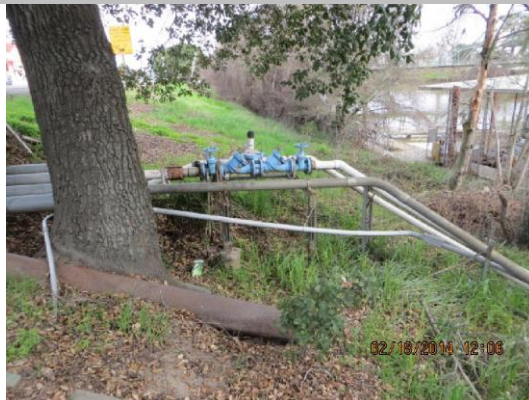
Photo 2 of 2 : UCIP\_SP\_2019\_30356\_55832.jpg

Blue backflow preventer with two shutoff valves visible on WS shoulder.

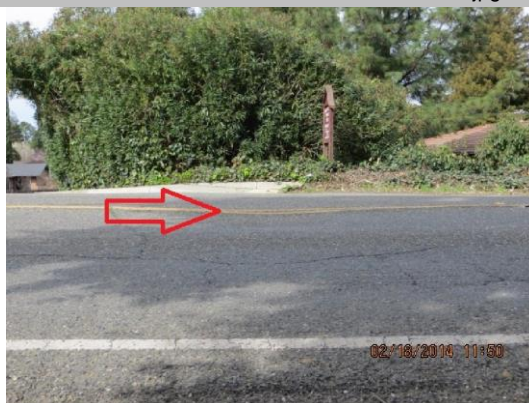
Photo 3 of 3 : UCIP\_SP\_2019\_30345\_55787.jpg

Depression over pipe alignment in crown/roadway.

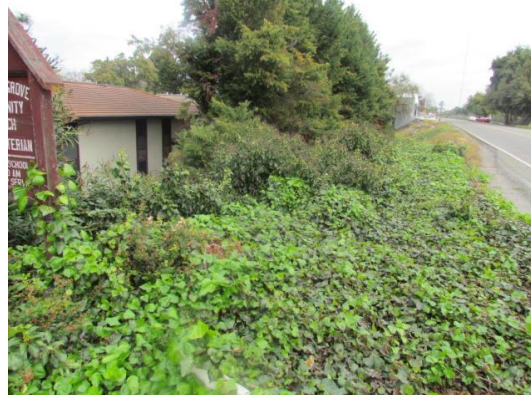
Photo 1 of 2 : SP\_2019\_RD0003\_25\_83\_20190311\_00062.jpg

Looking north at dense landscaping on landside shoulder and slope.

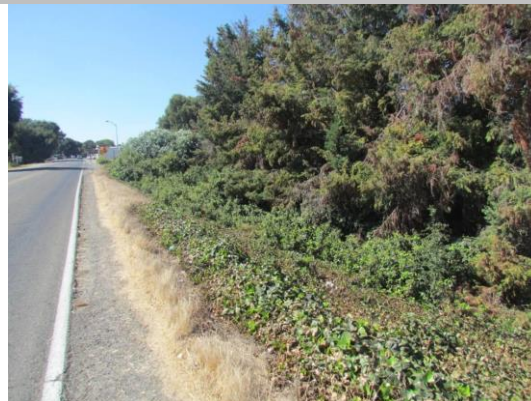
Photo 2 of 2 : SP\_2019\_RD0003\_25\_83\_20190311\_00063.jpg

Looking south at dense landscaping on landward shoulder and slope.

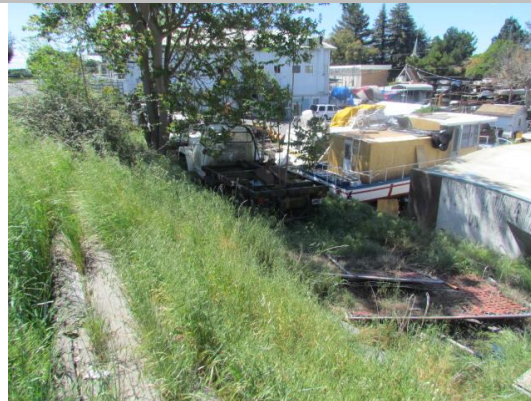
Photo 1 of 2 : SP\_2019\_RD0003\_25\_86\_20190311\_00066.jpg

LM Start	11.90	Rating **	M	Issue No.	86
LM End	11.90	Issue Type +	En	Location *	LS
Category	Earthen Levee			GPS Latitude/Longitude	
				Start	End
Item	Encroachments			38.244942 °	38.244942 °
				-121.513132 °	-121.513132 °
DWR ID	DWR_RD0003_02_s_2013_86				
Comment Code					
AV : Abandoned vehicles					
Inspector Comment					
Abandoned vehicles and material are on the landside toe.

Looking south at abandoned vehicles and material on landward slope and toe.

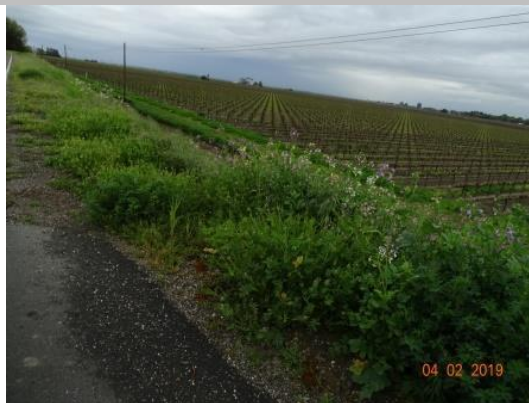
Photo 1 of 2 : SP\_2019\_RD0003\_25\_115\_20190404\_00325.jpg

LM Start	12.04	Rating **	M	Issue No.	115
LM End	17.21	Issue Type +	Ma	Location *	LS
Category	Earthen Levee			GPS Latitude/Longitude	
				Start	End
Item	Vegetation			38.246690 °	38.302622 °
				-121.511985 °	-121.572522 °
DWR ID	DWR_RD0003_02_s_2019_115				
Comment Code					
V1 : Control annual grass and weeds on the levee slopes and easements.					
Inspector Comment					
Control annual vegetation.

View looking downstream at annual vegetation on the landside slope (Spring 2019).

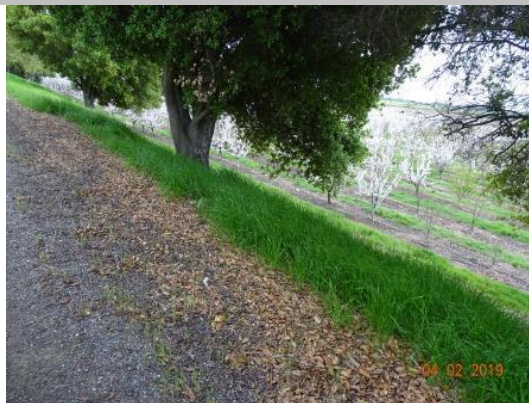
Photo 2 of 2 : SP\_2019\_RD0003\_25\_115\_20190404\_00326.jpg

LM Start	12.04	Rating **	M	Issue No.	115 (cont)	
LM End	17.21	Issue Type +	Ma	Location *	LS	
Category	Earthen Levee			GPS Latitude/Longitude		
				Start		End
Item	Vegetation			38.246690 °		38.302622 °
				-121.511985 °		-121.572522 °
DWR ID	DWR_RD0003_02_s_2019_115					
Comment Code						
V1 : Control annual grass and weeds on the levee slopes and easements.						
Inspector Comment						
Control annual vegetation.

View looking downstream at annual vegetation on the landside slope (Spring 2019).

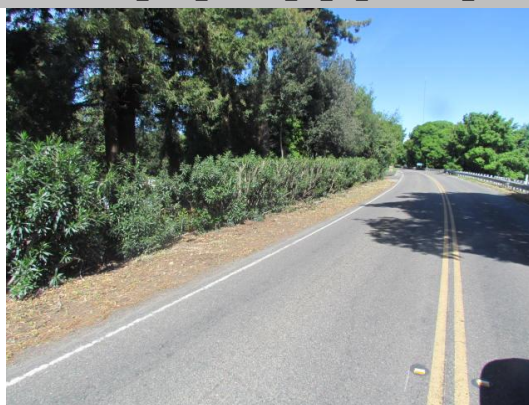
Photo 1 of 2 : SP\_2019\_RD0003\_25\_32\_20190311\_00028.jpg

LM Start	12.04	Rating **	M	Issue No.	32
LM End	12.18	Issue Type +	En	Location *	LS
Category	Earthen Levee			GPS Latitude/Longitude	
				Start	End
Item	Vegetation			38.246802 °	38.248682 °
				-121.511956 °	-121.511657 °
DWR ID	DWR_RD0003_02_s_2012_32				
Comment Code					
V6 : Landscaping					
Inspector Comment					
An oleander is partially blocking the view of levee on the landside slope.

Looking northwest at trimmed oleander partially blocking view of landward slope. (Spring 2015)

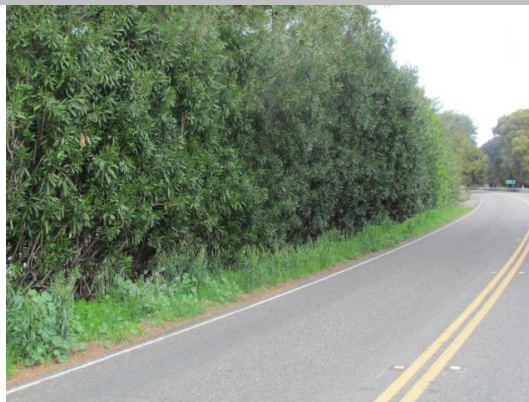
Photo 2 of 2 : SP\_2019\_RD0003\_25\_32\_20190311\_00029.jpg

Looking northwest at oleander on landside shoulder. (Spring 2014)

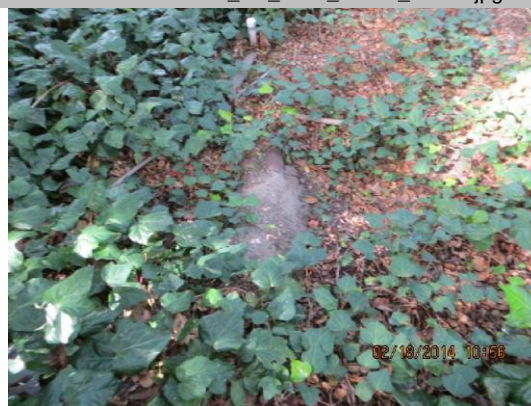
Photo 1 of 3 : UCIP\_SP\_2019\_30306\_55726.jpg

Comment Code						
Inspector Comment						
FS_ID:30306 DS_ID:22296 EP_NO: 2383 Repair Type: Non-Urgent Crossing Status: Found UCIP Comments: Annular space should be grouted. No permit identified for pipes sleeved through irrigation pipe. FIELD_STRUCT_DESC: 6-inch steel irrigation discharge pipe through the levee, 4 feet below the crown. Pump and gate valve on the waterside (WS) slope. A 4-inch pipe is sleeved through the 6-inch pipe. Two conduits are sleeved through the 4-inch pipe: A 1-inch water line and a 1.5-inch electrical conduit provide service to a boat dock, 210 feet upstream from the pump. (Plans for the installation of a pump on the WS slope and a 6-inch discharge pipe through the levee, 4 feet below the crown, authorized under Permit No. 2383, 1956 - James S. and Nancy P. Moser). The 4-inch pipe and two conduits were sleeved through the 6-inch pipe at a later date and likely without a permit. [Additional Reference(s): DWR Levee Log, 1993]. FS Date: 2/18/2014

6-inch pipe visible on LS toe.

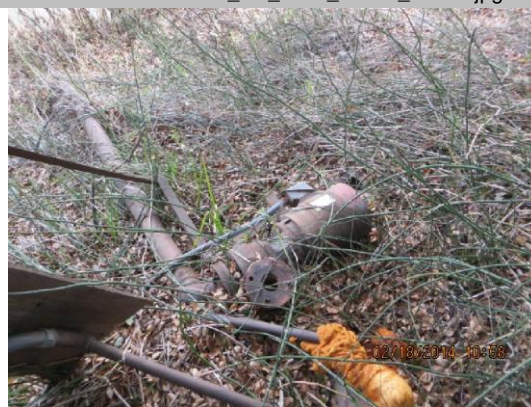
Photo 2 of 3 : UCIP\_SP\_2019\_30306\_55729.jpg

Pipe and pump visible on WS slope.

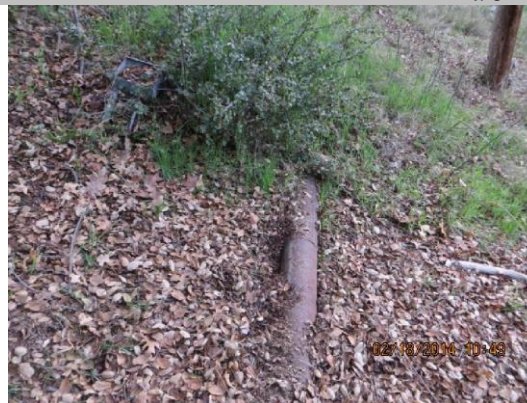
Photo 3 of 3 : UCIP\_SP\_2019\_30305\_55723.jpg

Abandoned pipe visible on LS slope.

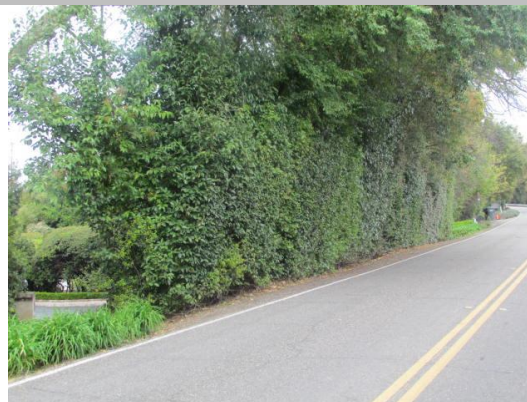
Photo 1 of 1 : SP\_2019\_RD0003\_25\_34\_20190311\_00030.jpg

LM Start	12.29	Rating **	U	Issue No.	34
LM End	12.36	Issue Type +	En	Location *	LS
Category	Earthen Levee			GPS Latitude/Longitude	
				Start	End
Item	Vegetation			38.250348 °	38.251292 °
				-121.511959 °	-121.512384 °
DWR ID	DWR_RD0003_02_s_2012_34				
Comment Code					
V6 : Landscaping					
Inspector Comment

Looking northwest at dense landscaping on landside shoulder.

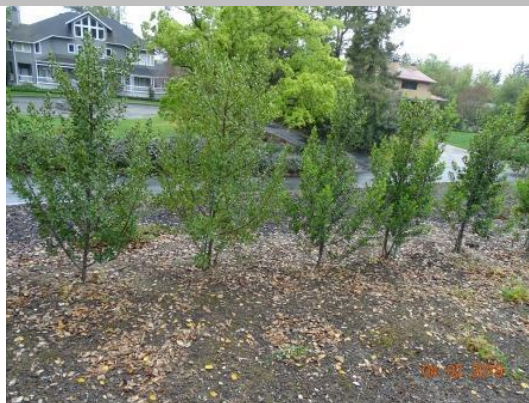
Photo 1 of 2 : SP\_2019\_RD0003\_25\_35\_20190404\_00321.jpg

LM Start	12.38	Rating **	U	Issue No.	35
LM End	12.47	Issue Type +	En	Location *	LS
Category	Earthen Levee			GPS Latitude/Longitude	
				Start	End
Item	Vegetation			38.251463 °	38.252711 °
				-121.512458 °	-121.513214 °
DWR ID	DWR_RD0003_02_s_2012_35				
Comment Code					
V6 : Landscaping					
Inspector Comment					
Remove newly planted trees from the landside.

View of newly planted trees on the landside slope (Spring 2019).

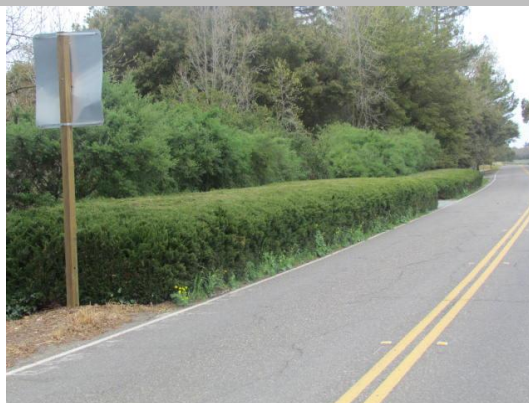
Photo 1 of 1 : SP\_2019\_RD0003\_25\_37\_20190311\_00032.jpg

LM Start	12.54	Rating **	U	Issue No.	37
LM End	12.65	Issue Type +	En	Location *	LS
Category	Earthen Levee			GPS Latitude/Longitude	
				Start	End
Item	Vegetation			38.253593 °	38.254832 °
				-121.513883 °	-121.515098 °
DWR ID	DWR_RD0003_02_s_2012_37				
Comment Code					
V6 : Landscaping					
Inspector Comment					
There is dense landscaping on the landside shoulder and slope.

Looking northwest at dense landscaping on landside shoulder and slope.

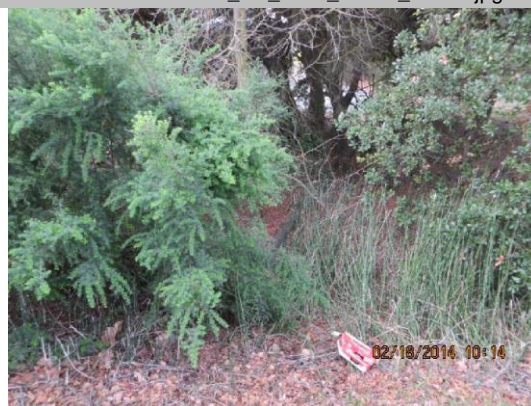
Photo 1 of 3 : UCIP\_SP\_2019\_40544\_55694.jpg

Comment Code					
Inspector Comment					
FS_ID:40544 DS_ID:22299 EP_NO: 1376 Repair Type: Non-Urgent Crossing Status: Found UCIP Comments: Pipe abandoned and should be done so properly. Pipe rusted through at various locations. FIELD_STRUCT_DESC: 12-inch steel irrigation discharge pipe through the levee, invert elevation 5 feet below the crown. Pump is missing from the waterside (WS) slope, and a steel plate is bolted over the end of the pipe. 42-inch concrete standpipe at the landside (LS) toe. 1.5-inch steel electrical conduit through the levee at the same location. (Plans for installing a vertical unit irrigation pumping plant and a 12-inch steel discharge pipe through the levee authorized under Permit No. 1376, 1949 - Joseph Gwerder Estate). [Additional Reference(s): DWR Levee Log, 1993. USACE Sacramento O&M Manual 104, February 1960, (RM 27.59)]. FS Date: 2/18/2014

Pipe visible on LS slope.

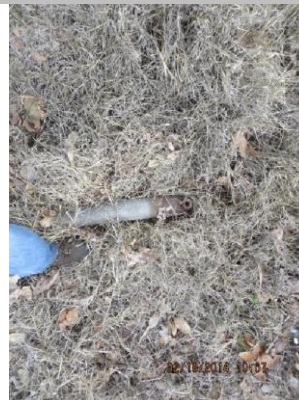
Photo 2 of 3 : UCIP\_SP\_2019\_30286\_55688.jpg

Pipe visible on LS slope with broken vent.

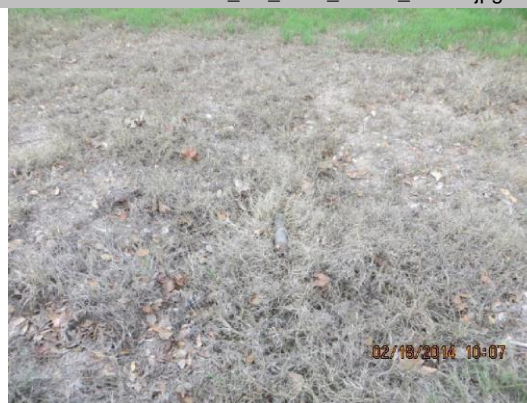
Photo 3 of 3 : UCIP\_SP\_2019\_30286\_55687.jpg

Pipe visible on LS slope.

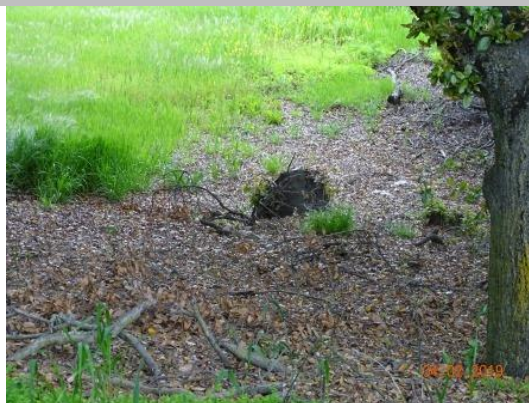
Photo 1 of 1 : SP\_2019\_RD0003\_25\_135\_20190404\_00331.jpg

LM Start	12.88	Rating **	N	Issue No.	135
LM End	12.88	Issue Type +	Ma	Location *	LS
Category	Earthen Levee			GPS Latitude/Longitude	
				Start	End
Item	Trim / Thin Trees			38.257244 °	38.257244 °
				-121.518037 °	-121.518037 °
DWR ID	DWR_RD0003_02_s_2018_135				
Comment Code					
T5 : Tree stumps.					
Inspector Comment					
There is a tree stump at levee toe.

View looking downslope at tree trunk at the bottom of the landside slope (Spring 2019).

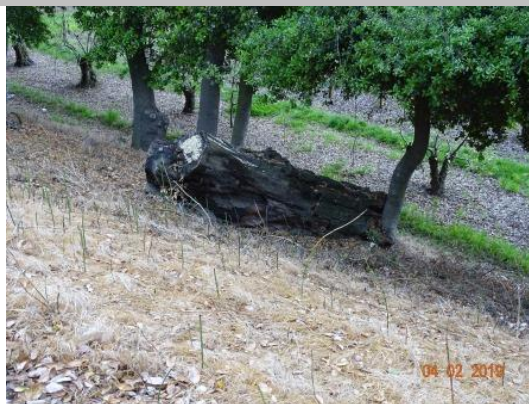
Photo 1 of 1 : SP\_2019\_RD0003\_25\_147\_20190404\_00330.jpg

LM Start	12.97	Rating **	U	Issue No.	147
LM End	12.97	Issue Type +	En	Location *	LS
Category	Earthen Levee			GPS Latitude/Longitude	
				Start	End
Item	Encroachments			38.258108 °	38.258108 °
				-121.519272 °	-121.519272 °
DWR ID	DWR_RD0003_02_s_2019_147				
Comment Code					
TR : Tree or limb					
Inspector Comment					
Remove the large log from the landside slope.

View looking downslope at tree trunk on the landside slope (Spring 2019).

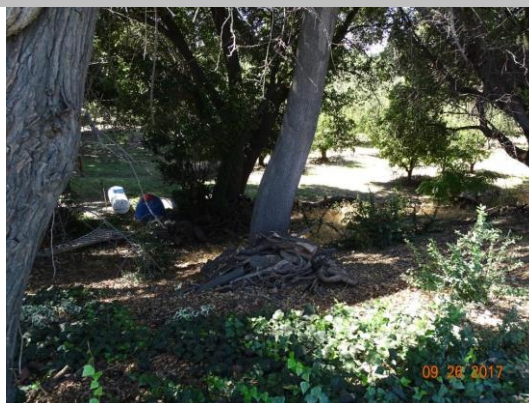
Photo 1 of 1 : SP\_2019\_RD0003\_25\_133\_20190311\_00097.jpg

LM Start	13.06	Rating **	M	Issue No.	133
LM End	13.06	Issue Type +	En	Location *	LS
Category	Earthen Levee			GPS Latitude/Longitude	
				Start	End
Item	Encroachments			38.258962 °	38.258962 °
				-121.520385 °	-121.520385 °
DWR ID	DWR_RD0003_02_s_2017_133				
Comment Code					
PR : Prunings					
Inspector Comment					
Debris and prunings are at the landside toe.

Looking southwest at the landside slope.

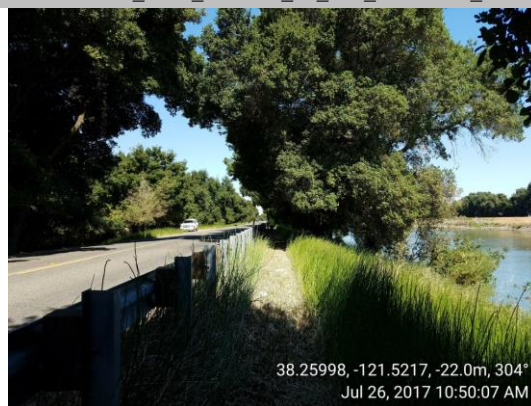
Photo 3 of 3 : SP\_2019\_RD0003\_25\_139\_20190311\_00109.jpg

LM Start	13.15	Rating **	A/W	Issue No.	139 (cont)	
LM End	13.17	Issue Type +	Ma	Location *		
Category	Supplemental			GPS Latitude/Longitude		
				Start	End	
Item	2017 Storm Damage			38.260042 °	38.260219 °	
				-121.521581 °	-121.521803 °	
DWR ID	DWR_RD0003_02_f_2017_139					
Comment Code						
Inspector Comment						
Levee Evaluation Comments						
Description: District station 694+80 to 695+69, Sec. 27, 1. 5 N. R. 4 E., M.D.M. Approximately 89 linear feet of erosion and sloughing exists along the water side slope of the Sacramento River (Unit 2). The erosion commences approximately 1/2 of the way down the slope from the crown and extends into the rip rap.						
Site ID No: 281						
Site Designation: LMA-107						
Repair Type: Erosion						
Rating: Area of Concern						
Field Date: 7/26/2017						
Notes:

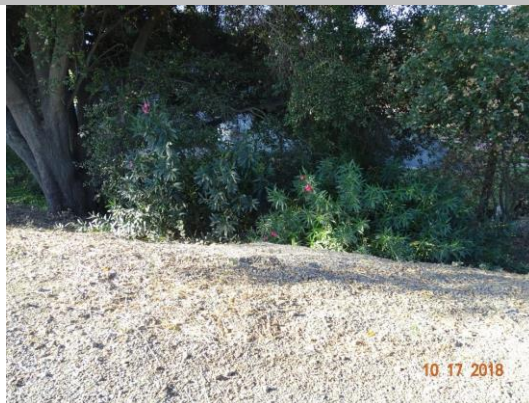
Photo 1 of 1 : SP\_2019\_RD0003\_25\_128\_20190311\_00090.jpg

LM Start	13.36	Rating **	M	Issue No.	128
LM End	13.36	Issue Type +	En	Location *	LS
Category	Earthen Levee			GPS Latitude/Longitude	
				Start	End
Item	Vegetation			38.262027 °	38.262027 °
				-121.524312 °	-121.524312 °
DWR ID	DWR_RD0003_02_f_2018_128				
Comment Code					
V6 : Landscaping					
Inspector Comment					
Oleanders are blocking the view of the landside slope.

View of oleanders on the landside toe (October 2018).

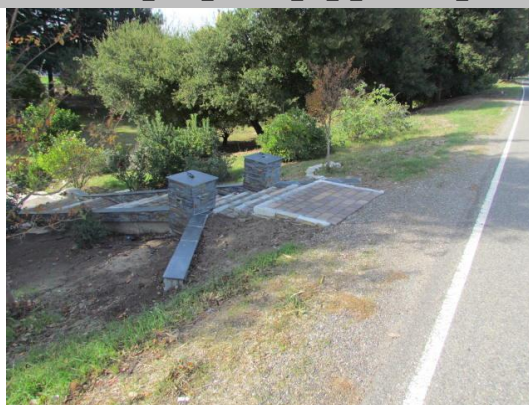
Photo 1 of 2 : SP\_2019\_RD0003\_25\_9\_20190311\_00009.jpg

LM Start	13.36	Rating **	M	Issue No.	9
LM End	13.36	Issue Type +	En	Location *	LS
Category	Earthen Levee			GPS Latitude/Longitude	
				Start	End
Item	Encroachments			38.262125 °	38.262125 °
				-121.524405 °	-121.524405 °
DWR ID	DWR_RD0003_02_s_2012_9				
Comment Code					
ST : Stairway					
Inspector Comment					
Landowner installed unauthorized stairs on the landside slope. There is no permit on record for these stairs.

Looking northwest at stairs on landside slope.

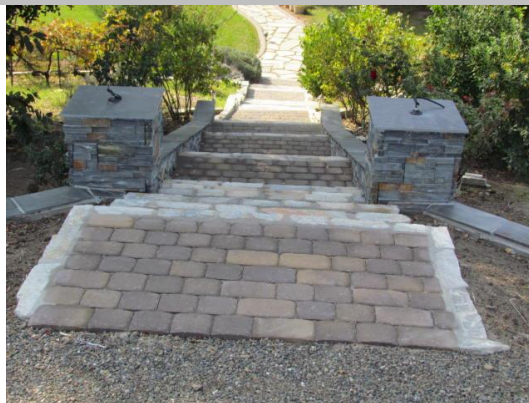
Photo 2 of 2 : SP\_2019\_RD0003\_25\_9\_20190311\_00010.jpg

Looking west at stairs on landside slope.

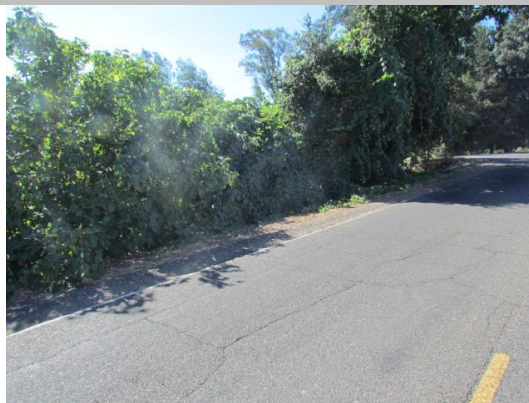
Photo 1 of 2 : SP\_2019\_RD0003\_25\_99\_20190311\_00075.jpg

LM Start	13.40	Rating **	M	Issue No.	99
LM End	13.40	Issue Type +	En	Location *	LS
Category	Earthen Levee			GPS Latitude/Longitude	
				Start	End
Item	Vegetation			38.262449 °	38.262449 °
				-121.524899 °	-121.524899 °
DWR ID	DWR_RD0003_02_f_2015_99				
Comment Code					
V6 : Landscaping					
Inspector Comment					
Figs trees and other plants are blocking the view of the landside slope.

Looking westly at dense vegetation on landward shoulder and slope. (Spring 2016)

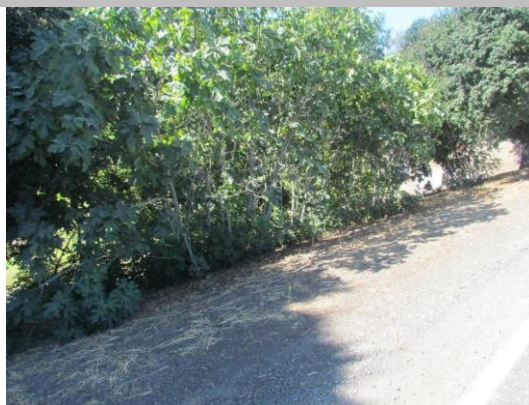
Photo 2 of 2 : SP\_2019\_RD0003\_25\_99\_20190311\_00076.jpg

LM Start	<b>13.40</b>	Rating **	M	Issue No.	<b>99 (cont)</b>
LM End	<b>13.40</b>	Issue Type +	En	Location *	LS

Looking westly at fig trees on landward slope. (Fall 2016)

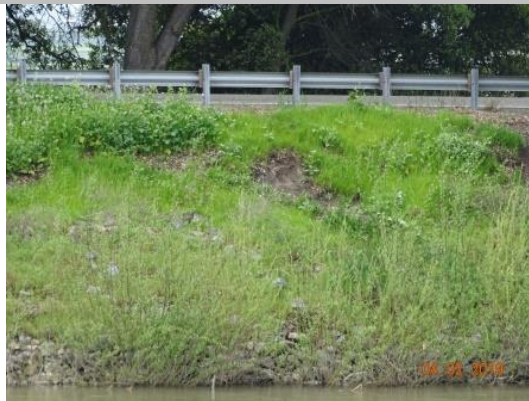
Photo 1 of 1 : SP\_2019\_RD0003\_25\_204\_20190404\_00319.jpg

LM Start	13.43	Rating **	A/W	Issue No.	204
LM End	13.43	Issue Type +	Ma	Location *	WS
Category	Earthen Levee			GPS Latitude/Longitude	
				Start	End
Item	Erosion / Bank Caving			38.262822 °	-121.525300 °
				38.262822 °	-121.525300 °
DWR ID	DWR_RD0003_02_s_2019_204				
Comment Code					
E1 : Note and monitor erosion site.					
Inspector Comment					
Inspect potential erosion spot further when vegetation is less dense in the fall.

View looking across the Sacramento River at potential erosion spot towards the top of the waterside slope (Spring 2019).

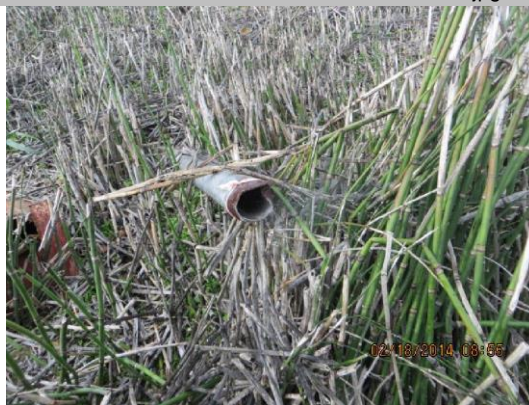
Photo 3 of 3 : UCIP\_SP\_2019\_30204\_55603.jpg

LM Start	13.70	Rating **	M	Issue No.	994 (cont)	
LM End	13.70	Issue Type +	En	Location *		
Category	Supplemental			GPS Latitude/Longitude		
				Start	End	
Item	DWR UCIP Field Study			38.265479 °	38.265479 °	
				-121.528825 °	-121.528825 °	
DWR ID	22307					
Comment Code						
Inspector Comment						
FS_ID:30204 DS_ID:22307 EP_NO: N/A Repair Type: Non-Urgent Crossing Status: Found UCIP Comments: Abandoned and should be done so properly as it is open on both ends. FIELD_STRUCT_DESC: *ABANDONED* 2-inch electrical conduit of an unknown material through the levee, 5.5 feet below the crown. (Open on both ends by USACE, Unit 15, in 1969). [Additional Reference(s): DWR Levee Log, 1993]. FS Date: 2/18/2014

Pipe open on both ends.

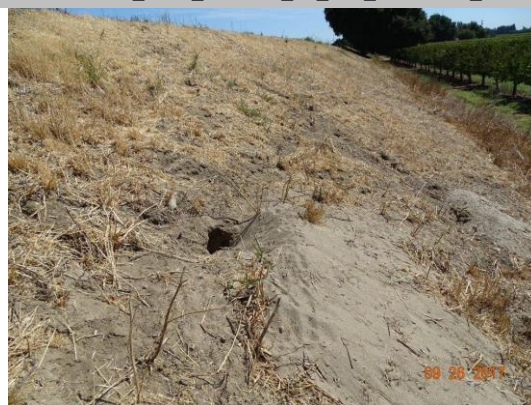
Photo 1 of 1 : SP\_2019\_RD0003\_25\_169\_20190311\_00145.jpg

LM Start	<b>13.86</b>	Rating **	A/W	Issue No.	<b>169</b>
LM End	<b>13.86</b>	Issue Type +	Ma	Location *	LS
Category	Earthen Levee		GPS Latitude/Longitude		
			Start	End	
Item	Animal Control		38.267084 °	38.267084 °	
			-121.530939 °	-121.530939 °	
DWR ID	DWR_RD0003_02_f_2017_169				
Comment Code					
A1 : Exterminate rodents and backfill and compact or grout burrows.					
Inspector Comment

Looking southeast at the landside slope.

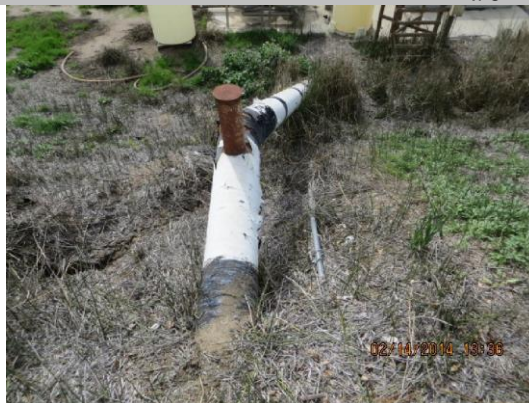
Photo 1 of 3 : UCIP\_SP\_2019\_30203\_55602.jpg

Comment Code						
Inspector Comment						
FS_ID:30203 DS_ID:22308 EP_NO: N/A Repair Type: Non-Urgent Crossing Status: Found UCIP Comments: Erosion next to pipe on LS slope. FIELD_STRUCT_DESC: 16-inch steel irrigation discharge pipe through the levee, 3 feet below the crown. 14-inch pipe sleeved through the 16-inch pipe and a 1.5-inch steel electrical conduit at the same location. Slant pump on the waterside (WS) slope and a filter plant at the landside (LS) toe. [Additional Reference(s): DWR Levee Log, 1993, referenced as 5.6 feet below the crown. USACE Sacramento O&M Manual 104, February 1960, (RM 28.91), referenced as invert elevation 5.6 feet below the crown]. FS Date: 2/14/2014

Pipe, vent, and electrical conduit visible on LS slope.

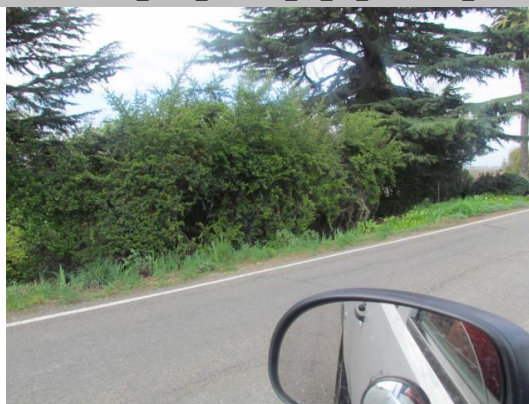
Photo 1 of 1 : SP\_2019\_RD0003\_25\_50\_20190311\_00035.jpg

LM Start	14.11	Rating **	M	Issue No.	50
LM End	14.17	Issue Type +	En	Location *	LS
Category	Earthen Levee			GPS Latitude/Longitude	
				Start	End
Item	Vegetation			38.269528 °	38.270113 °
				-121.534428 °	-121.535268 °
DWR ID	DWR_RD0003_02_s_2012_50				
Comment Code					
V6 : Landscaping					
Inspector Comment

Looking west at landscaping on landside slope.

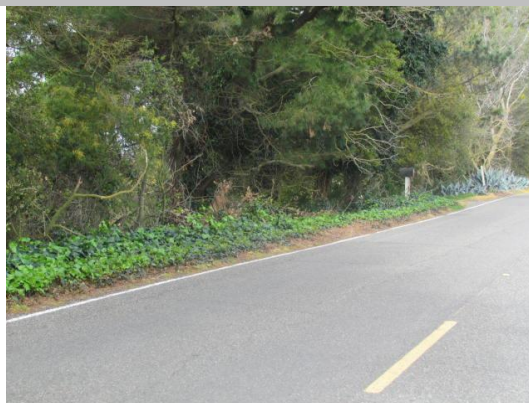
Photo 2 of 2 : SP\_2019\_RD0003\_25\_72\_20190311\_00047.jpg

Looking northwest at dense landscaping on landside shoulder and slope.

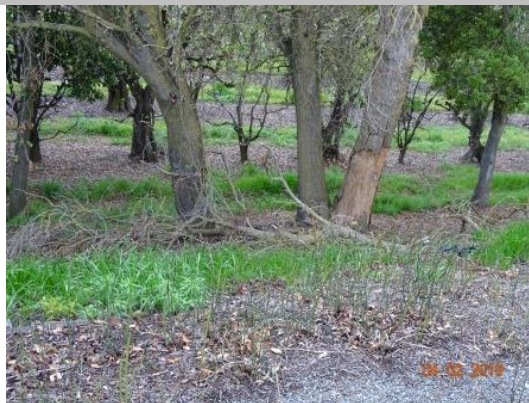
Photo 1 of 1 : SP\_2019\_RD0003\_25\_132\_20190404\_00329.jpg

LM Start	14.29	Rating **	M	Issue No.	132
LM End	14.29	Issue Type +	En	Location *	LS
Category	Earthen Levee			GPS Latitude/Longitude	
				Start	End
Item	Encroachments			38.271342 °	38.271342 °
				-121.536844 °	-121.536844 °
DWR ID	DWR_RD0003_02_s_2019_132				
Comment Code					
TR : Tree or limb					
Inspector Comment					
Remove tree limbs from the landside slope.

View looking downslope at tree limbs on the landside slope (Spring 2019).

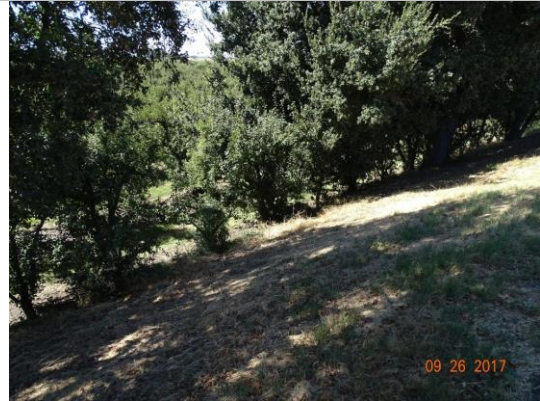
Photo 1 of 1 : SP\_2019\_RD0003\_25\_168\_20190311\_00144.jpg

LM Start	14.32	Rating **	M	Issue No.	168
LM End	14.40	Issue Type +	En	Location *	LS
Category	Earthen Levee			GPS Latitude/Longitude	
				Start	End
Item	Encroachments			38.271622 °	38.272350 °
				-121.537290 °	-121.538245 °
DWR ID	DWR_RD0003_02_f_2017_168				
Comment Code					
CR : Crops					
Inspector Comment					
Landowner has planted pear trees at the toe of the levee.

Looking northwest at the landside slope.

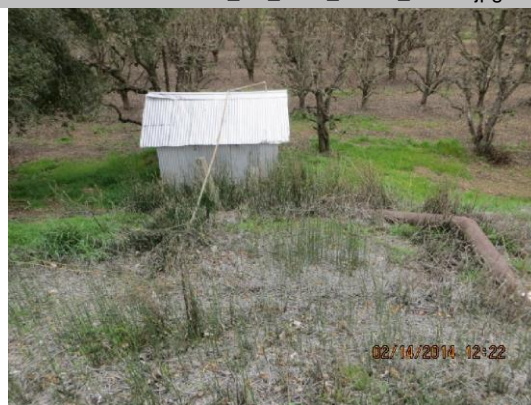
Photo 1 of 3 : UCIP\_SP\_2019\_30164\_55565.jpg

Comment Code					
Inspector Comment					
FS_ID:30164 DS_ID:22370 EP_NO: N/A Repair Type: Non-Urgent Crossing Status: Indicator Found UCIP Comments: Pipe abandoned and should be verified as having been done so properly. FIELD_STRUCT_DESC: *ABANDONED* 7-inch steel pipe of an unknown purpose through the levee, invert elevation 4.6 feet below the crown. (Green). 1.5-inch electrical conduit through the levee at the same location. Depression in-line with pump house on the waterside (WS) is a good indicator of the pipe location. 36-inch concrete standpipe at the landside (LS) toe. [DWR Levee Log, 1993. USACE Sacramento O&M Manual 104, February 1960, (RM 29.94)]. FS Date: 2/14/2014

Pumphouse on LS toe good indicator of abandoned pipe location.

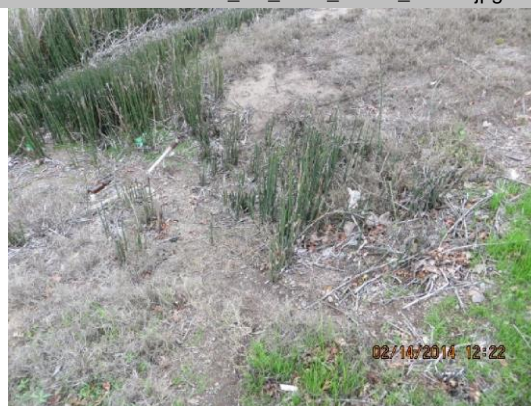
Photo 2 of 3 : UCIP\_SP\_2019\_30164\_55564.jpg

Depression on WS slope and electrical conduit at approximate location of pipe.

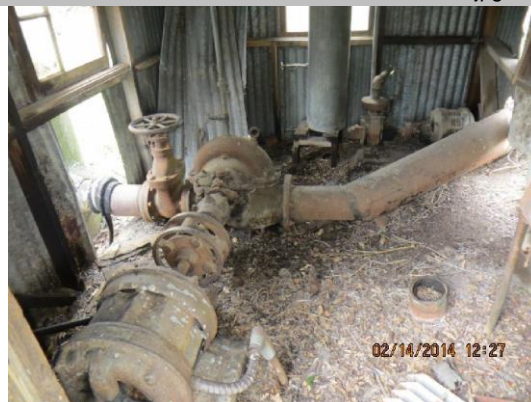
Photo 3 of 3 : UCIP\_SP\_2019\_30164\_55563.jpg

Original pump now used for 10-inch.

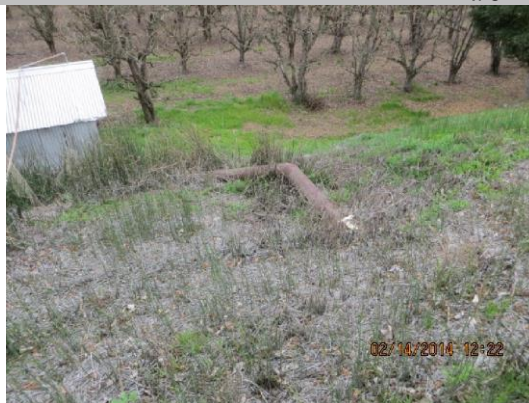
Photo 1 of 3 : UCIP\_SP\_2019\_30165\_55568.jpg

Comment Code						
Inspector Comment						
FS_ID:30165 DS_ID:22369 EP_NO: 919 Repair Type: Non-Urgent Crossing Status: Found UCIP Comments: Appears abandoned and if so should be done so properly. FIELD_STRUCT_DESC: 10-inch steel irrigation discharge pipe through the levee, invert elevation 3.8 feet below the crown. Pump and gate valve in a pump house at the landside (LS) toe. 2-inch filler pipe at the same location, 3 feet below the crown. (Plans for the installation of a 10-inch, 7-gauge welded steel pipe through the levee authorized under Permit No. 919, 1943 - Dell Kercheval). [Additional Reference(s): DWR Levee Log, 1993. USACE Sacramento O&M Manual 104, February 1960 (RM 29.94)]. FS Date: 2/14/2014

Pipe visible on LS slope.

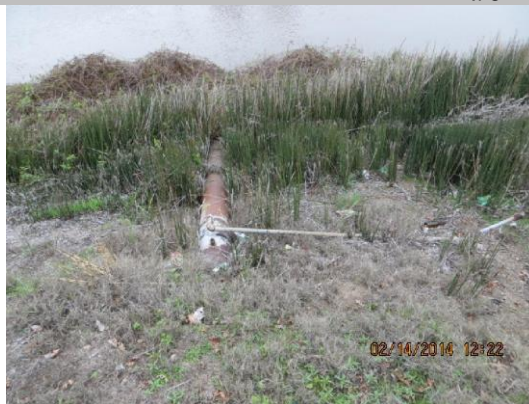
Photo 2 of 3 : UCIP\_SP\_2019\_30165\_55567.jpg

Pipe visible on WS slope and filler pipe visible.

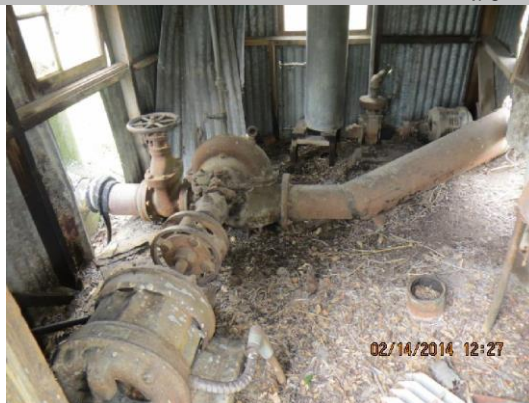
Photo 3 of 3 : UCIP\_SP\_2019\_30165\_55566.jpg

Item	DWR UCIP Field Study			38.277631 °	38.277631 °	
				-121.544718 °	-121.544718 °	
DWR ID	22369					
Comment Code						
Inspector Comment						
FS_ID:30165 DS_ID:22369 EP_NO: 919 Repair Type: Non-Urgent Crossing Status: Found UCIP Comments: Appears abandoned and if so should be done so properly. FIELD_STRUCT_DESC: 10-inch steel irrigation discharge pipe through the levee, invert elevation 3.8 feet below the crown. Pump and gate valve in a pump house at the landside (LS) toe. 2-inch filler pipe at the same location, 3 feet below the crown. (Plans for the installation of a 10-inch, 7-gauge welded steel pipe through the levee authorized under Permit No. 919, 1943 - Dell Kercheval). [Additional Reference(s): DWR Levee Log, 1993. USACE Sacramento O&M Manual 104, February 1960 (RM 29.94)]. FS Date: 2/14/2014

Pump and gate valve visible in pumphouse. Connection to concrete standpipe failing.

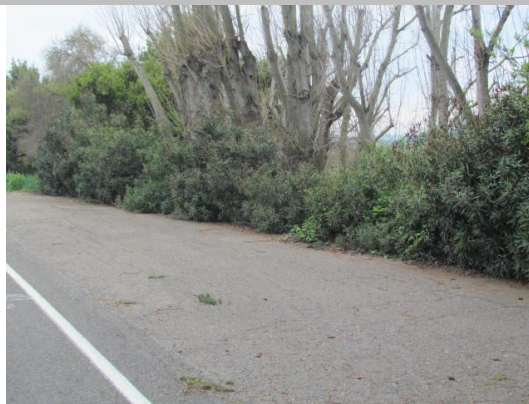
Photo 1 of 1 : SP\_2019\_RD0003\_25\_53\_20190311\_00036.jpg

LM Start	14.96	Rating **	U	Issue No.	53
LM End	15.02	Issue Type +	En	Location *	LS
Category	Earthen Levee			GPS Latitude/Longitude	
				Start	End
Item	Vegetation			38.278237 °	38.278930 °
				-121.545405 °	-121.546218 °
DWR ID	DWR_RD0003_02_s_2012_53				
Comment Code					
V6 : Landscaping					
Inspector Comment

Looking southeast at dense landscape on landward slope.

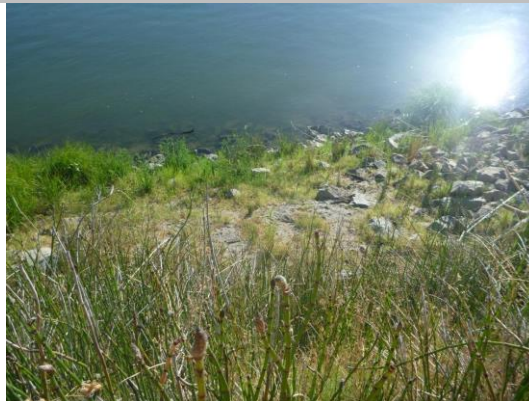
Photo 3 of 3 : SP\_2019\_RD0003\_25\_142\_20190311\_00114.jpg

LM Start	15.00	Rating **	A/W	Issue No.	142 (cont)	
LM End	15.07	Issue Type +	Ma	Location *		
Category	Supplemental			GPS Latitude/Longitude		
				Start	End	
Item	2017 Storm Damage			38.278806 °	38.279444 °	
				-121.545817 °	-121.546647 °	
DWR ID	DWR_RD0003_02_f_2017_142					
Comment Code						
Inspector Comment						
Levee Evaluation Comments						
Description: District station 792+44 to 795+74, Sec. 16, T. 5 N. R. 4 E., M.D.M. Approximately 330 linear feet of erosion and sloughing exists along the water side slope of the Sacramento River (Unit 2). The erosion commences approximately 1/2 of the way down the slope from the crown and extends into the rip rap.						
Site ID No: 282						
Site Designation: LMA-108						
Repair Type: Erosion						
Rating: Area of Concern						
Field Date: 7/28/2017						
Notes: no berm

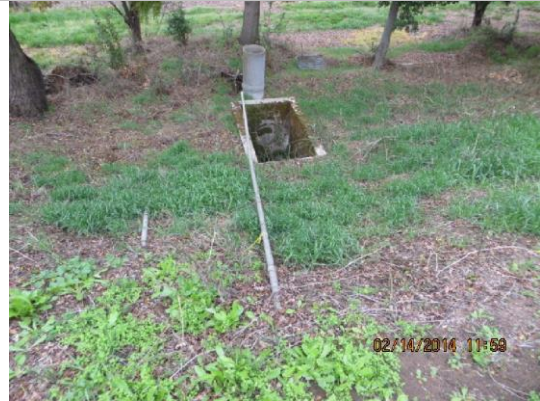
Photo 1 of 3 : UCIP\_SP\_2019\_53292\_55542.jpg

Comment Code					
Inspector Comment					
FS_ID:53292 DS_ID:22371 EP_NO: N/A Repair Type: Urgent Crossing Status: Found UCIP Comments: 07/20/2018 Everything appears to be the same as last time. No changes have been made. No new pipe has been put in. Crossing remains "Urgent" because of the holes visible in 2014. (DWR UCIP - A. McDonald)07/06/2016 Heavy vegetation prevented visibility. Per RD0003 president David Robertson, WS erosion repaired last Spring. Could not fully see any repair work done. Need to return when vegetation cleared. Appears abandoned and if so should be done properly. (DWR UCIP - K. Fazel)02/14/2014 Pipe rusted through on WS slope. Appears abandoned and should be done so properly. Erosion of WS slope under pipe on WS toe. (DWR FPIIB - G. Wylie) FIELD_STRUCT_DESC: *ABANDONED* 12-inch steel irrigation discharge pipe through the levee, invert elevation 7 feet below the crown. Slant pump next to old pump house on the waterside (WS) slope. 2-inch filler pipe at the same location. 4-foot by 8-foot concrete distribution box and standpipe at the landside (LS) toe. (Plans to replace a 12-inch steel pipe through the levee authorized under Permit No. 7082, 1974 - Pacific Fruit Farms). Permit was canceled. Original pipe remains. [Additional Reference(s): DWR Levee Log, 1993. USACE Sacramento O&M Manual 104, February 1960, (RM 30.30)]. FS Date: 7/20/2018

Concrete distribution box on LS toe with electrical conduit visible.
